# CONSOLIDATION OF CATHEDRAL OF PORTO

*Paulo B. Lourenço, ISISE, University do Minho, Department of Civil Engineering  
pbl@civil.uminho.pt*

The present paper presents the works recently carried out at the Cathedral of Porto as a case study of a difficult intervention that challenges current recommendations for the architectural heritage. The aspects regarding structural consolidation are addressed, including strengthening and monitoring of the towers and diagnostics of a chapel.

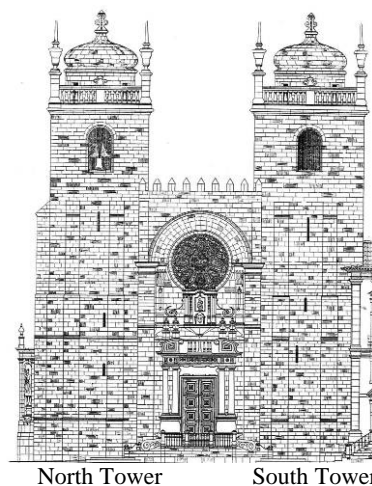
The main façade was built between 1176-1200 (central part) and 1229-1325 (towers), see Figure 1. The towers evolved into a Bell-tower (North) and a Clock-tower (South). In 1552, damage due to lightning is reported in the South tower. Between 1665-1669 the South tower was demolished up to mid-height and rebuilt. In 1717, it is recorded that the South tower was in the verge of collapse and, in 1727, buttresses were added, similarly to the ones that already existed in the North tower. Pinnacles were added in 1732. The construction of the Chapter House, contiguous to the South tower, also aimed at consolidating the tower. Also in this period, the two small windows in the main façade (South tower) were replaced by a single large window, similar to the one that existed in the North tower. Before 1841, a new lightning stroke the South tower.

Figure 1. Main façade after the restoration works in the first half of the 20th century.

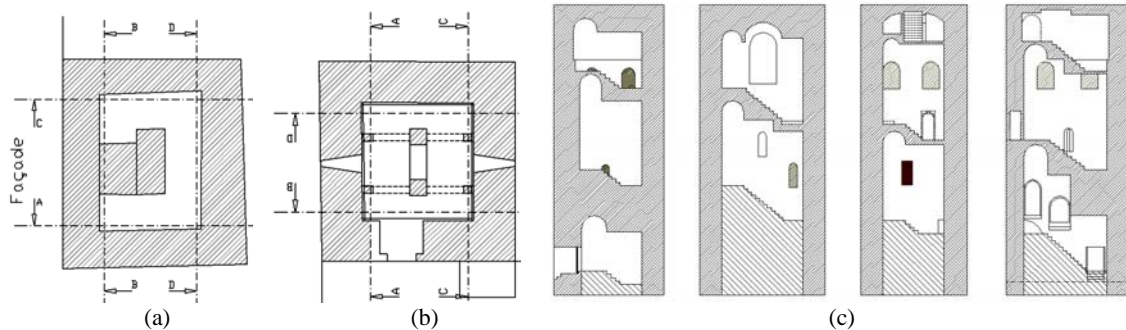
at mid-height, with a connection between both towers from the top of the main vault. But the two towers have a rather different structure. The South tower possesses an internal core with a staircase shaped helicoidally, see Figure 2a,c. The North tower (presently with the bells and clock) features a horizontal mid-level with stone slabs and architraves apparently supported in columns and stone struts, see Figure 2b.

Figure 2. Partial sections of the towers: (a) horizontal section of the South tower, (b) horizontal section of the North tower and (c) sections A-D for the South tower.

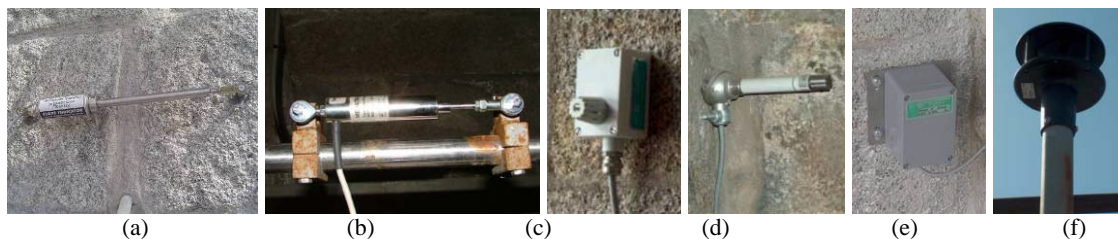
Figure 11. Examples of sensors placed: (a) crackmeter; (b) extensometer; (c) temperature sensor; (d) combined temperature and relative humidity sensor; (e) tiltmeter; (f) anemometer.

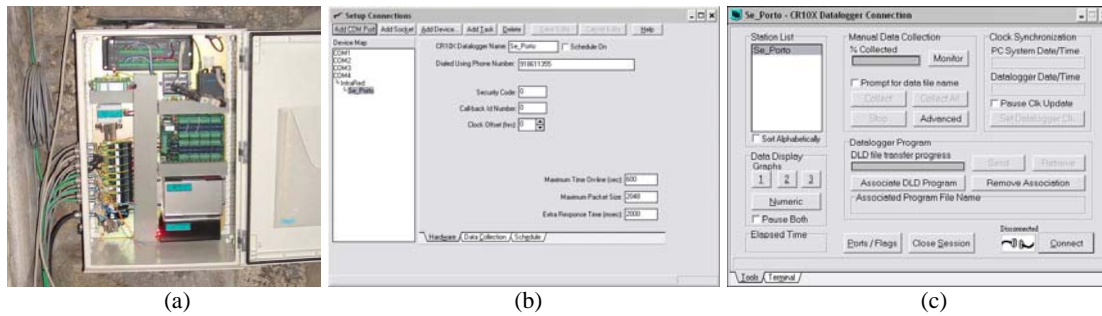
Figure 12. Data acquisition system and software: (a) datalogger; (b) GSM download; (c) manual data collection.

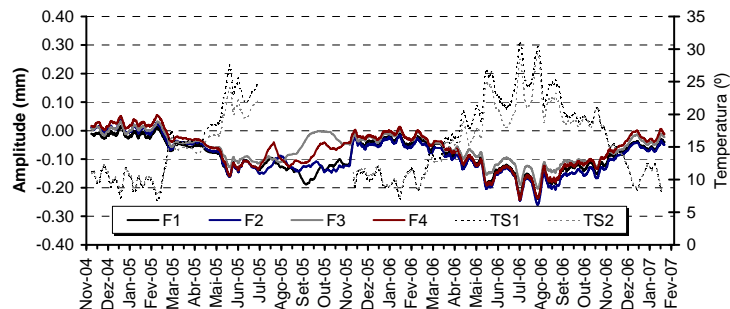
Given the cultural importance of the building and the significant damage in the South tower, a monitoring system was planned and installed. The system includes four waterproof crackmeters in the largest cracks, two strain gages for the new ties, two biaxial clinometers to measure the tilting of the tower, as well as temperature, humidity and wind sensors, see Figure 10 and Figure 11. The system includes a datalogger and a GSM interface for remote monitoring, see Figure 12. An example of the measured values, for the crackmeters and temperature sensors, indicate minor variations and the typical seasonal effects, thus confirming the adequacy of the intervention measures.

Figure 13. Example of results from crackmeters and temperature.
